**Expert Report of
Lawrence E. Eiselstein, Ph.D., P.E.**

**California Sportfishing Protection
Alliance (Plaintiff)**

**Pacific Bell Telephone Company
(Defendant)**

**Case No.
2:21-CV-00073-MCE-JDP**

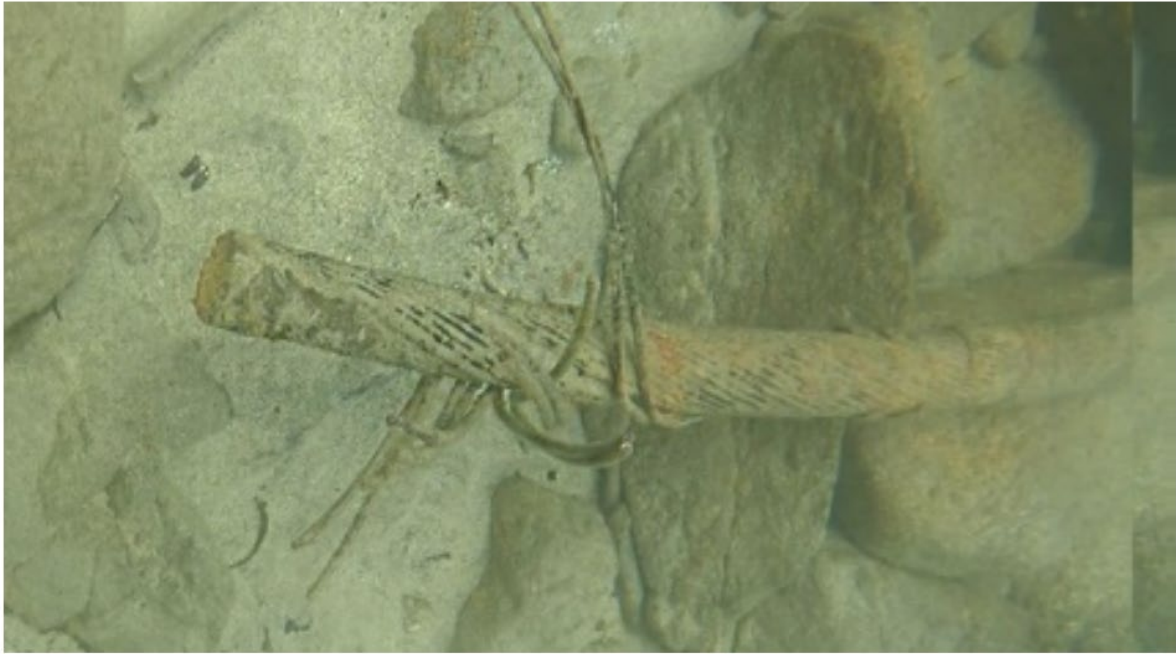
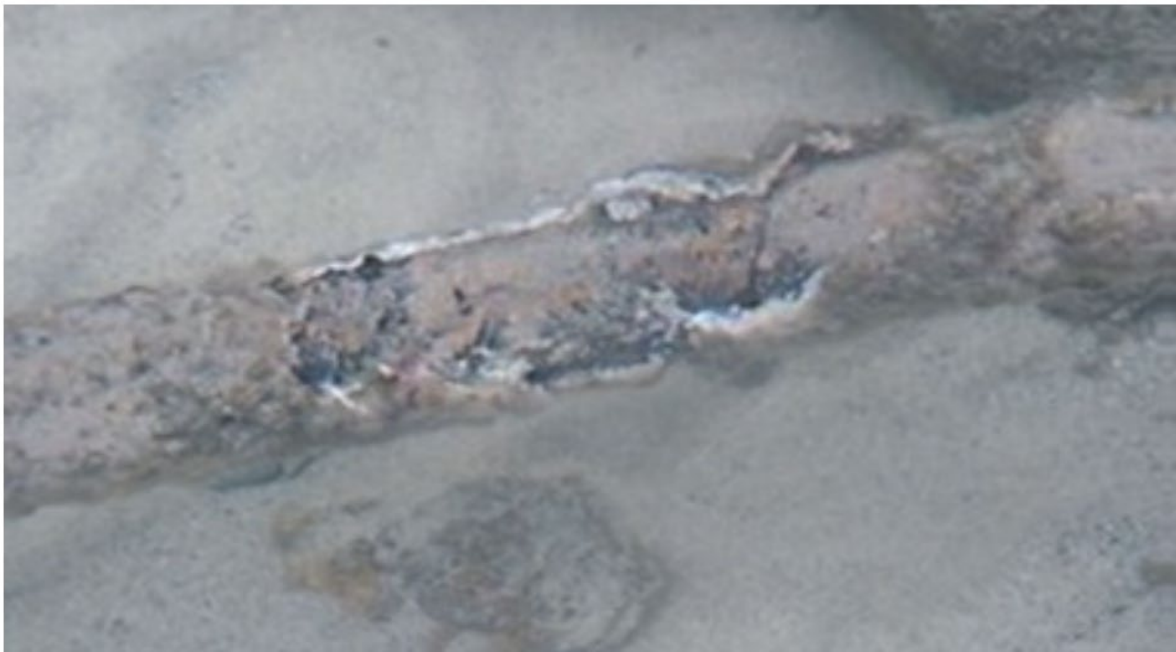
Figure 3. Haley & Aldrich photographs showing selected water sampling locations for Cables A and B in Lake Tahoe.²⁴

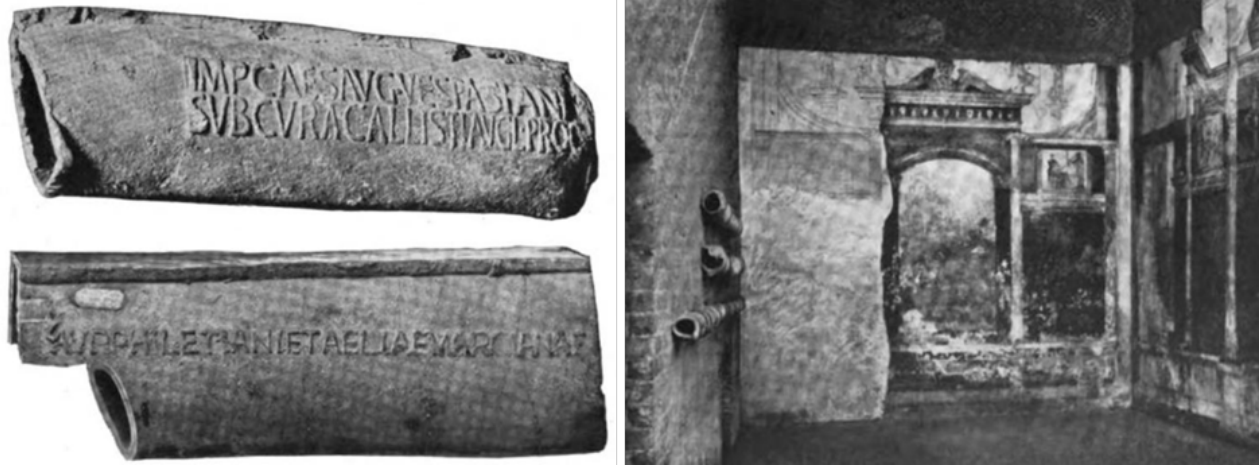
Figure 7. Left: lead pipes excavated in Roman soil after 1,800 years. The pipes are in sufficiently good condition that the inscriptions (which indicate Roman plumbing firms) are still clearly legible. Right: remains of a Roman home in 67 AD illustrating lead water pipes.⁴⁶

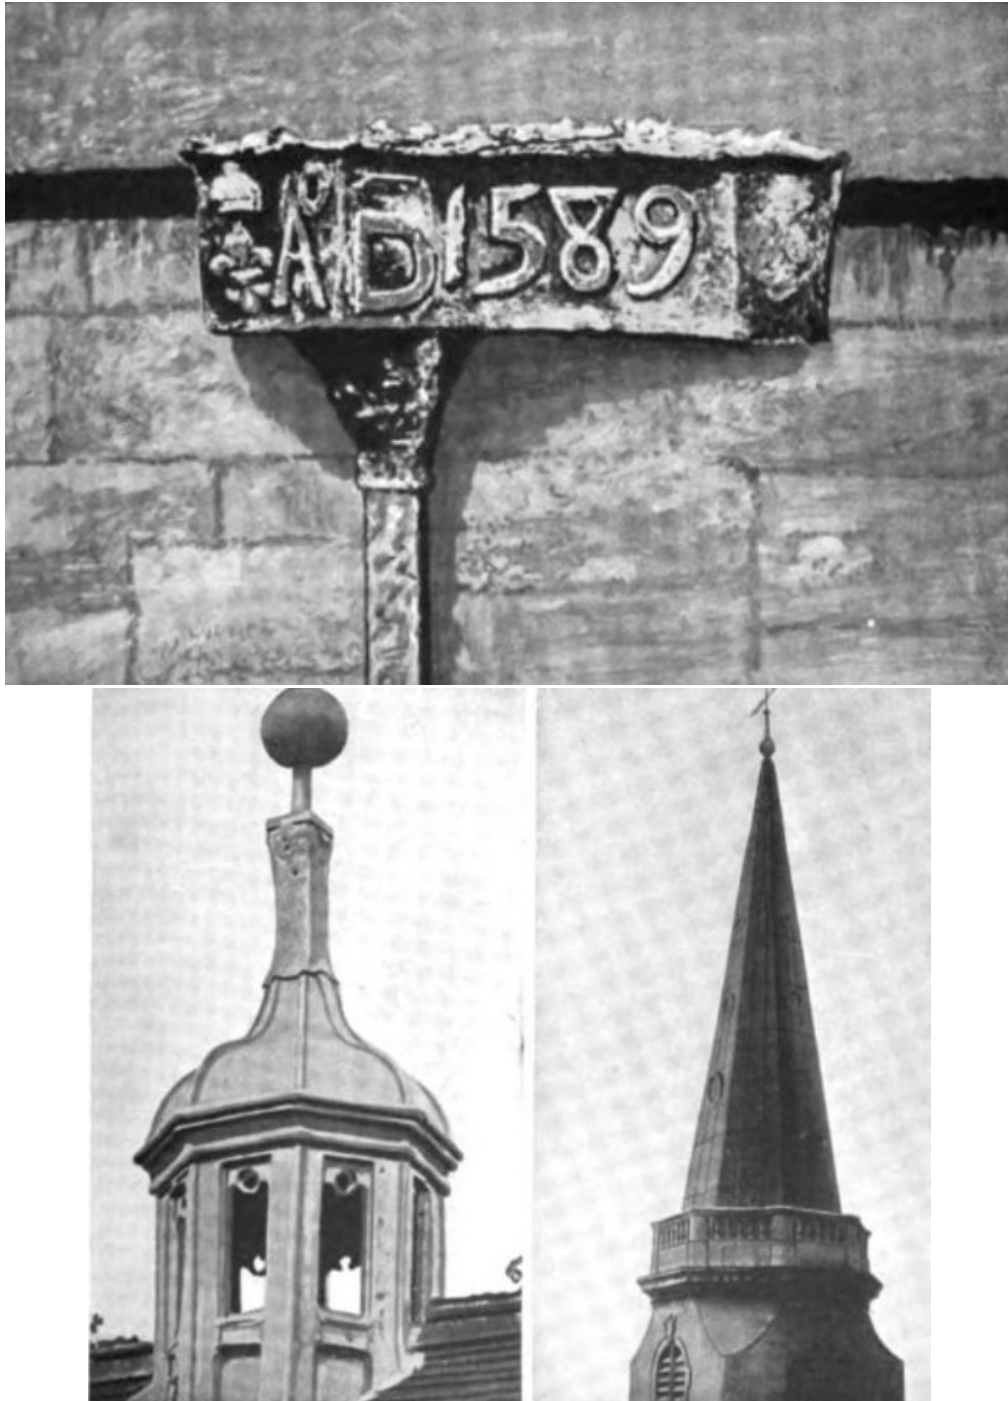
As discussed in Opinion 3 of this report, lead experiences less degradation due to environmental exposure compared to most other materials used for underground, atmospheric, and aqueous applications. Consequently, historical lead artifacts and structures have survived centuries or millennia prior to discovery by archeologists. For example, 1,800-year-old lead pipes were removed from the streets and cellars of Pompeii and Rome in “a perfect state of preservation,” as shown in Figure 7.⁴² Lead pipes from the Roman period of England were also excavated in good condition almost 1,900 years after their original installation.⁴³ Additionally, “[m]any magnificent buildings, erected in the 15th and 16th centuries, still stand under their original lead roofs.”⁴³ Also, as reported in 1924, a lead-covered dome built in 1553 in London (Barnard’s Inn Hall) still remains and a lead leader-pipe head on Windsor Castle which is inscribed with the year 1589 shows little evidence of corrosion, as shown in Figure 8.⁴⁴

Figure 8: Examples of lead structures: top image illustrates lead leader-pipe head on Windsor Castle from the sixteenth century; bottom images show a lead-covered dome (Barnard's Inn Hall, London) from 1553 AD (left), and a lead-covered spire (St. Swithin's Church, London) from 1682 AD (right).⁴⁷

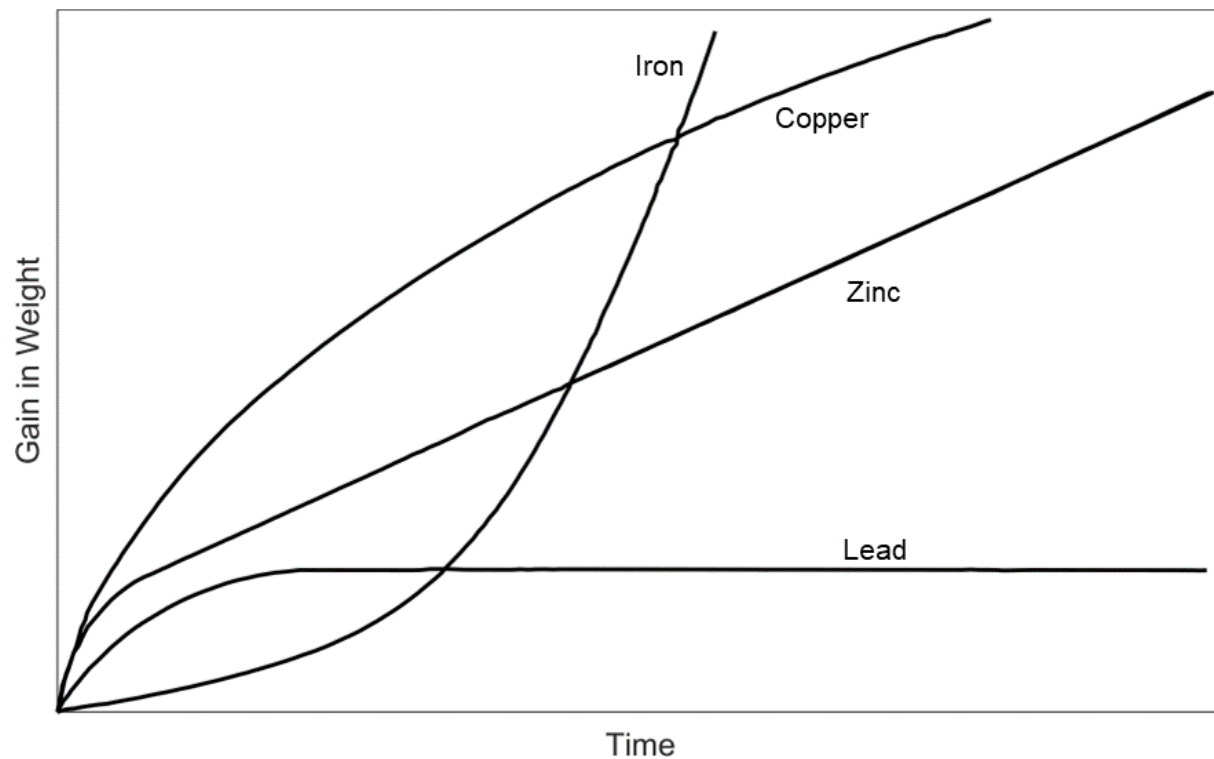
several metals including lead.⁶⁶ Figure 10 shows a plot from this article that depicts decreasing corrosion rates for copper, zinc, and lead with increasing exposure time to atmospheric conditions.⁶⁷ In this plot, the extent of corrosion is measured by “Gain in Weight” (shown on the y-axis). Weight gain occurs with corrosion because chemical species from the atmosphere react with the metal and become incorporated in the corrosion product. (Note that much of the academic literature, including other references cited in this report, discuss weight loss during corrosion testing rather than weight gain. This apparent discrepancy results from how corrosion testing is performed and does not reflect a fundamental difference in corrosion mechanisms—see Appendix D for additional details.)

If corrosion occurred at a constant rate, all the curves shown in Figure 10 would be linear (i.e., the slopes of the lines would not change over time). In fact, the slopes of the copper, zinc, and lead curves are initially steep (indicating relatively rapid gain in weight or corrosion) and the slopes decrease over time (indicating a slowing down of gain in weight or corrosion). In this specific instance, the lead curve slows down so much it appears to be horizontal, indicating that corrosion effectively slows to a degree that the rate of corrosion appears to drop to zero (although this is likely just the limit of the weight resolution used in this experiment). The review article explained this result on the basis that the passivating film on lead was “impervious to constituents of the environment.”⁶⁸ As noted above, the effectiveness of a passivating layer depends on its physical characteristics and properties as well as the specific environment. The next section of this report discusses passivating layers for lead in more detail.

Figure 10. Weight gain versus time for metals exposed to atmospheric conditions. Adapted from original reference.⁶⁹

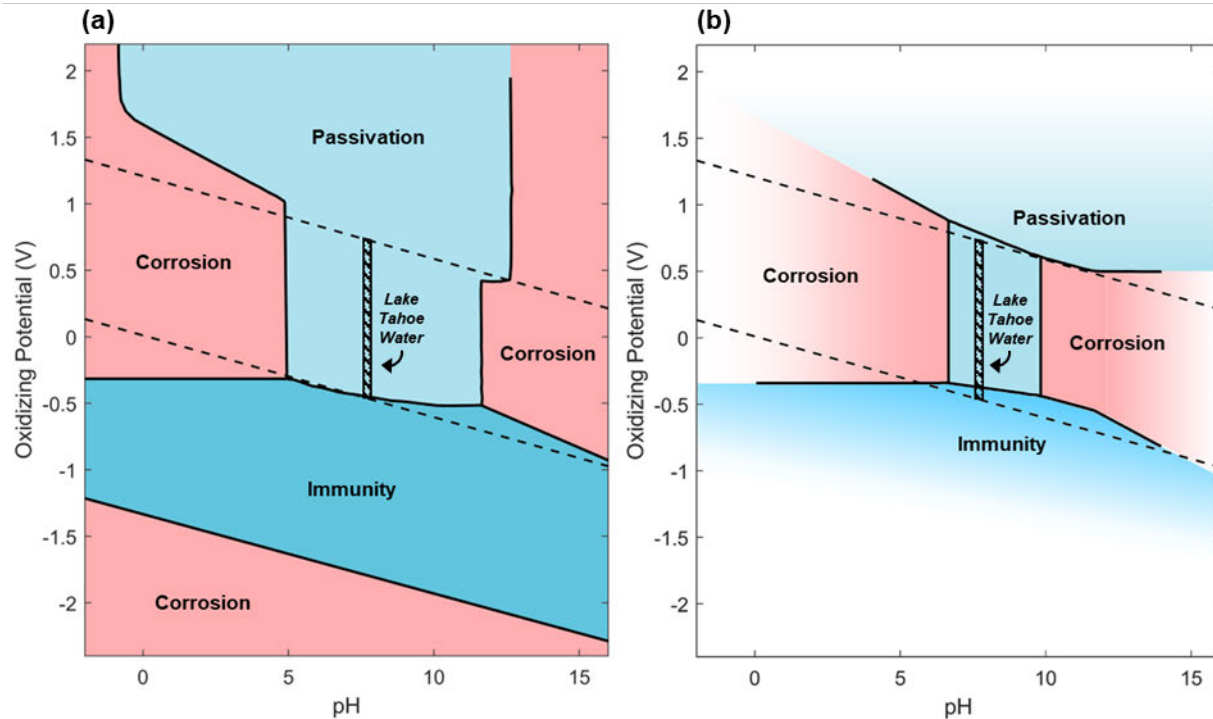
Figure 11. Examples of Pourbaix diagrams for lead. Hashed areas indicate the range of possible conditions in Lake Tahoe water based on measured pH values and physical limitations on water stability. (a) Pourbaix diagram of lead in the presence of solution containing CO_2 .⁷⁵ (b) Pourbaix diagram for lead in typical drinking water.⁷⁶ Plots were adapted by Exponent from their respective sources.

Figure 11 shows Pourbaix diagrams for lead in two different aqueous environments. Figure 11a corresponds to lead in the presence of water with CO_2 at one atmosphere partial pressure and 25°C . Figure 11b corresponds to lead in the presence of typical drinking water. Although I have not seen a Pourbaix diagram specifically developed for lead in the presence of Lake Tahoe water, the pH and oxidizing potential of Lake Tahoe water can be bounded and overlaid on the existing Pourbaix diagrams, as shown by the hashed areas on each plot.

When the known pH and oxidizing potential bounds for Lake Tahoe water are plotted on the Pourbaix diagrams in Figure 11, the bounded area is within the passivation or immunity regions. There is no overlap with the corrosion region in which lead ions would be freely released from the metal. This result suggests that in an environment like Lake Tahoe water, lead is expected to develop a passivating layer (or, if oxidizing potentials are low, it may not react at all). As discussed in the next section of this report, as well as Opinion 4, the development of a passivating layer does not necessarily mean that corrosion completely stops. However, the corrosion rate may be significantly slowed.
